# Manhole Inspection Summary

Manhole # S45C\_\_077MH

Insp Date: **8/19/08 8:27 AM**

**Location** Address: **Wolfe**

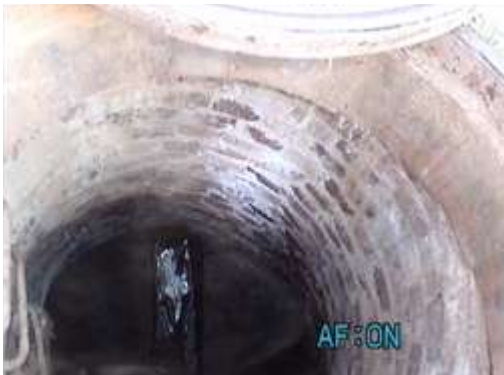
Defect 2

Frame leaks

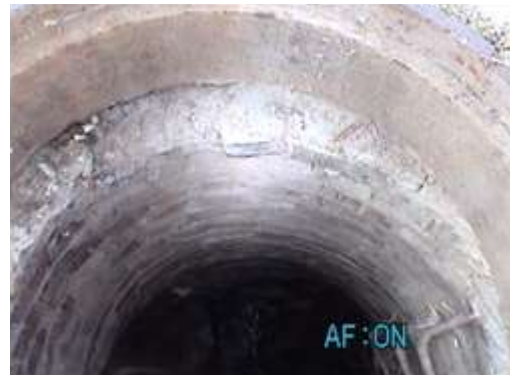
Defect 1

Infiltration: ☐ None ☒ **Joint** ☐ Cracks ☐ Mortar ☐ Roots ☐ Wall

Infiltration: ☐ None ☐ Joint ☐ Cracks ☐ Mortar ☐ Roots ☒ **Wall**

Infiltration

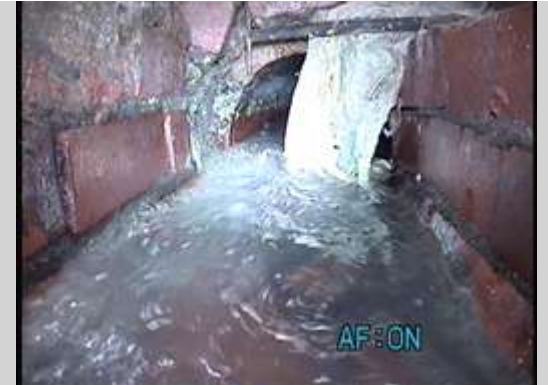
12 O'Clock Outflow

8 in. Circular Gravity Sewer  
Pipe Out @ 12 O'Clock

Pipe Height: **8.4** (in.) Rod and Bar (Angled)  
Pipe Material: **Clay** ☐ Pipe Lined  
Invert Depth: **8.55** (ft.) Flow Characteristics: **Fast**  
Deposits: ☒ None ☐ Mud ☐ Sludge ☐ Debris ☐ Grease  
Silt Depth: (in.) Deposits Extent:  
Infiltration: **None** Pipe Seal Cond: **Sound**

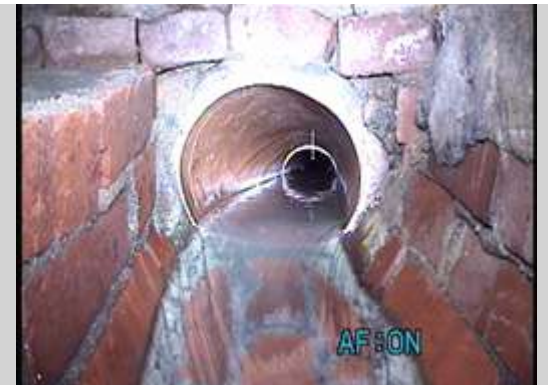
7 O'Clock Inflow

8 in. Circular Gravity Sewer  
Pipe In @ 6 O'Clock

Pipe Height: **8.4** (in.) Rod and Bar (Angled)  
Pipe Material: **Clay** ☐ Pipe Lined  
Invert Depth: **8.35** (ft.) Flow Characteristics: **Fast**  
Deposits: ☒ None ☐ Mud ☐ Sludge ☐ Debris ☐ Grease  
Silt Depth: (in.) Deposits Extent:  
Infiltration: **None** Pipe Seal Cond: **Sound**

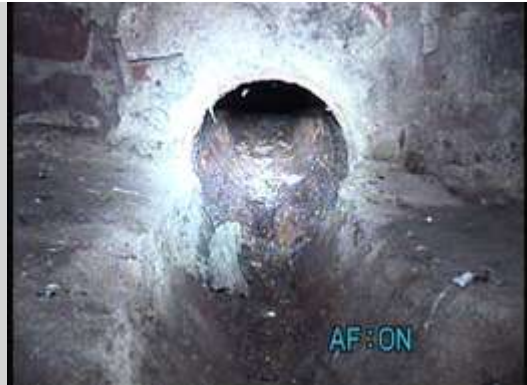
9 O'Clock Inflow

6 in. Circular Gravity Sewer

Pipe In @ 9 O'Clock

Pipe Height: **6** (in.) Rod and Bar (Angled)

Pipe Material: **Clay** ☐ Pipe Lined

Invert Depth: **7.60** (ft.) Flow Characteristics: **None**

Infiltration: **None**

Pipe Seal Cond: **Sound**
